Cure Evaluation of Two Critical Composite Hybrid Flat Panels for use in a High-Dimensional Stability Satellite Application

20 July 2003

R. J. ZALDIVAR and R. CASTENEDA
Space Materials Laboratory
Laboratory Operations

| 7. PERFORMING ORGANIZATION NAME(S) AND ADDRESS(ES) The Aerospace Corporation Laboratory Operations El Segundo, CA 90245-4691 | | | | 8. PERFORMING ORGANIZATION REPORT NUMBER TR-2003(8565)-6 | |

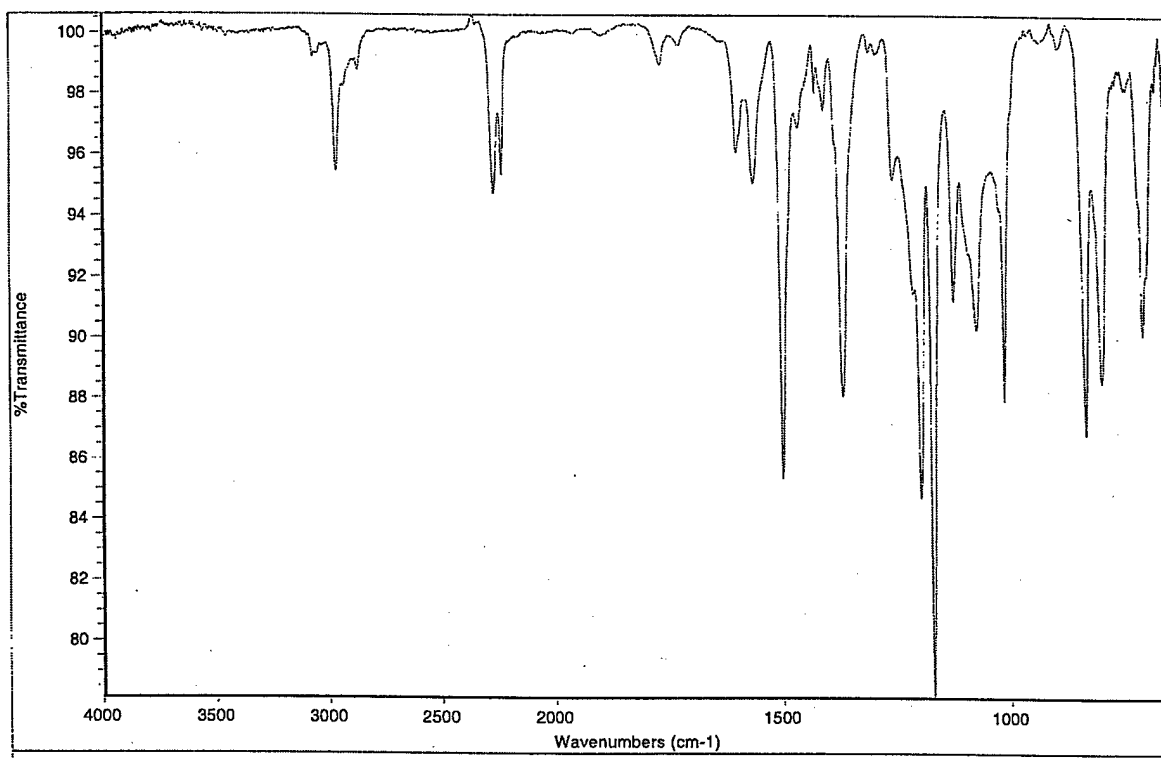
Figure 5. FTIR Spectra for typical siloxane modified cyanate ester resin.

three main areas of importance, as shown in the scans. The characteristic absorption bands of the cyanate ester groups are observed in the infrared spectrum between 2200 to 2300 cm^{-1} . The band is usually split into a doublet or triplet, depending on the chemical environment of the cyanate. Monitoring the disappearance of the cyanate ester absorbance bands can follow the polymerization of the resin. Even though this is generally a very good indicator of the degree of the initial stages of cure, identifying variations at higher degrees of cure is more difficult. A second set of peaks at 1560 and 1360 cm^{-1} reflects the absorption for the formation of the triazine ring as shown in Figure 6. The triazine ring is the primary polymerization route for this resin system. As this peak increases, the degree of cure increases; this is especially evident during the later stages of cure. Figure 6 shows an FTIR scan for the resin used in these composites as a function of the degree of cure. As shown from the figure, the polymerization can be followed quite readily for this system, especially at 1560 cm^{-1} .

The third peak to focus on is located at approximately 1750 cm^{-1} . This is a carbonyl peak that is usually indicative of hydrolysis of the cyanate ester occurring during the polymerization process. This type of carbamate contamination is the primary cause for large variations or decreases in the glass-transition temperature of the resin, even after heat treatment to high temperature. Figure 7 shows a typical FTIR with limited contamination.

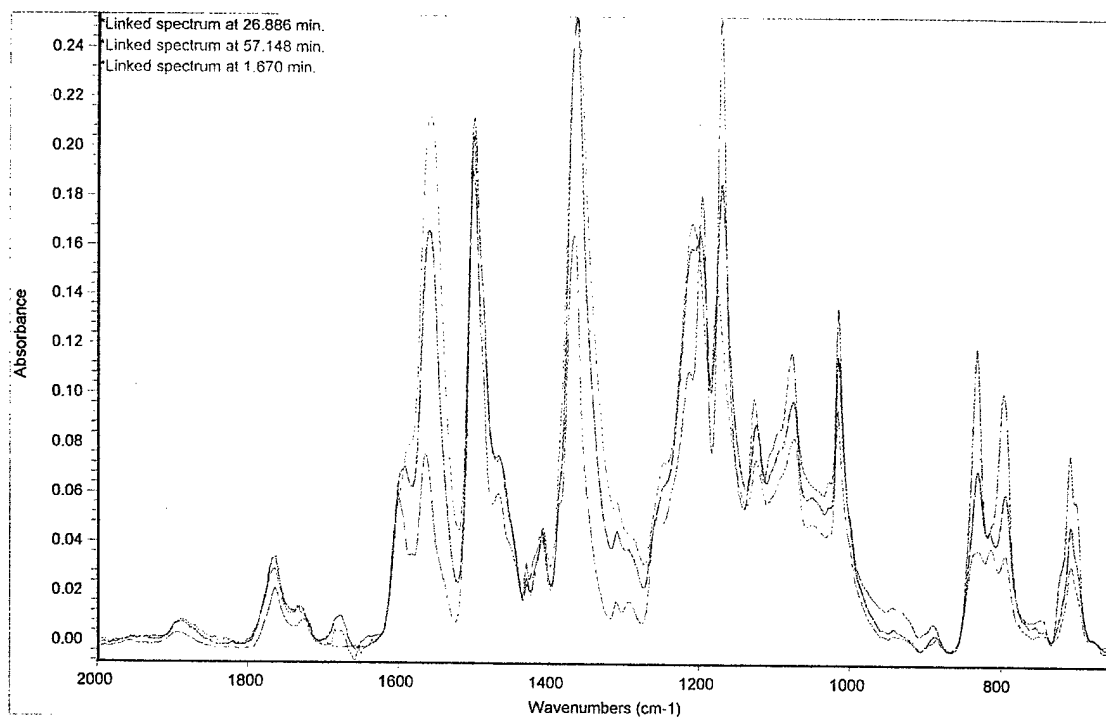
In parts from both composite panels evaluated, the cyanate peak at 2250 cm^{-1} was completely consumed. This is typical in samples that are cured over 70% unless there has been moisture contamination. In those cases, the cyanate peak can be completely consumed due to hydrolysis with a limited degree of polymerization. The degree of cure was further evaluated, normalizing the peak located at

Figure 6. FTIR Spectra showing development of triazine ring formation during cure as indicated by peaks located at 1560 and 1360 cm^{-1} .

1560 cm^{-1} for all parts taken from Panel 1 and Panel 2. Panel 2 appeared fully cured for all specimens and showed no evidence of hydrolysis contamination, which corroborates our measured Tg data. Panel 1, however, indicated a composite part that ranged in the degree of cure from 70 to 90%, depending on the location measured. The areas with the lowest degree of cure showed indications of carbamate formation. Even though by-products of hydrolysis were observed, the degree could not be easily quantified due to the convoluted nature of the peak.

- We do not recommend using Panel 1 due to the severe degree of contamination that has occurred to the composite. Bonding to the surface of the composite may greatly affect mechanical performance. However, Panel 2 appears to be fairly well cured, especially 1.0 in. in from the outer perimeter. Panel 2 appears satisfactory for use with respect to its degree of cure. Additional, flatwise tension tests should be performed to evaluate variability and strength.
